# **APPENDIX F**

*USACE Correspondence Letter and Identification of Waters  
of the U.S.: Madera Site*

PROJECT NAME: Brown Property  
Identification of Waters of the U.S.

Brown Property: I.D. of Waters of the U.S.

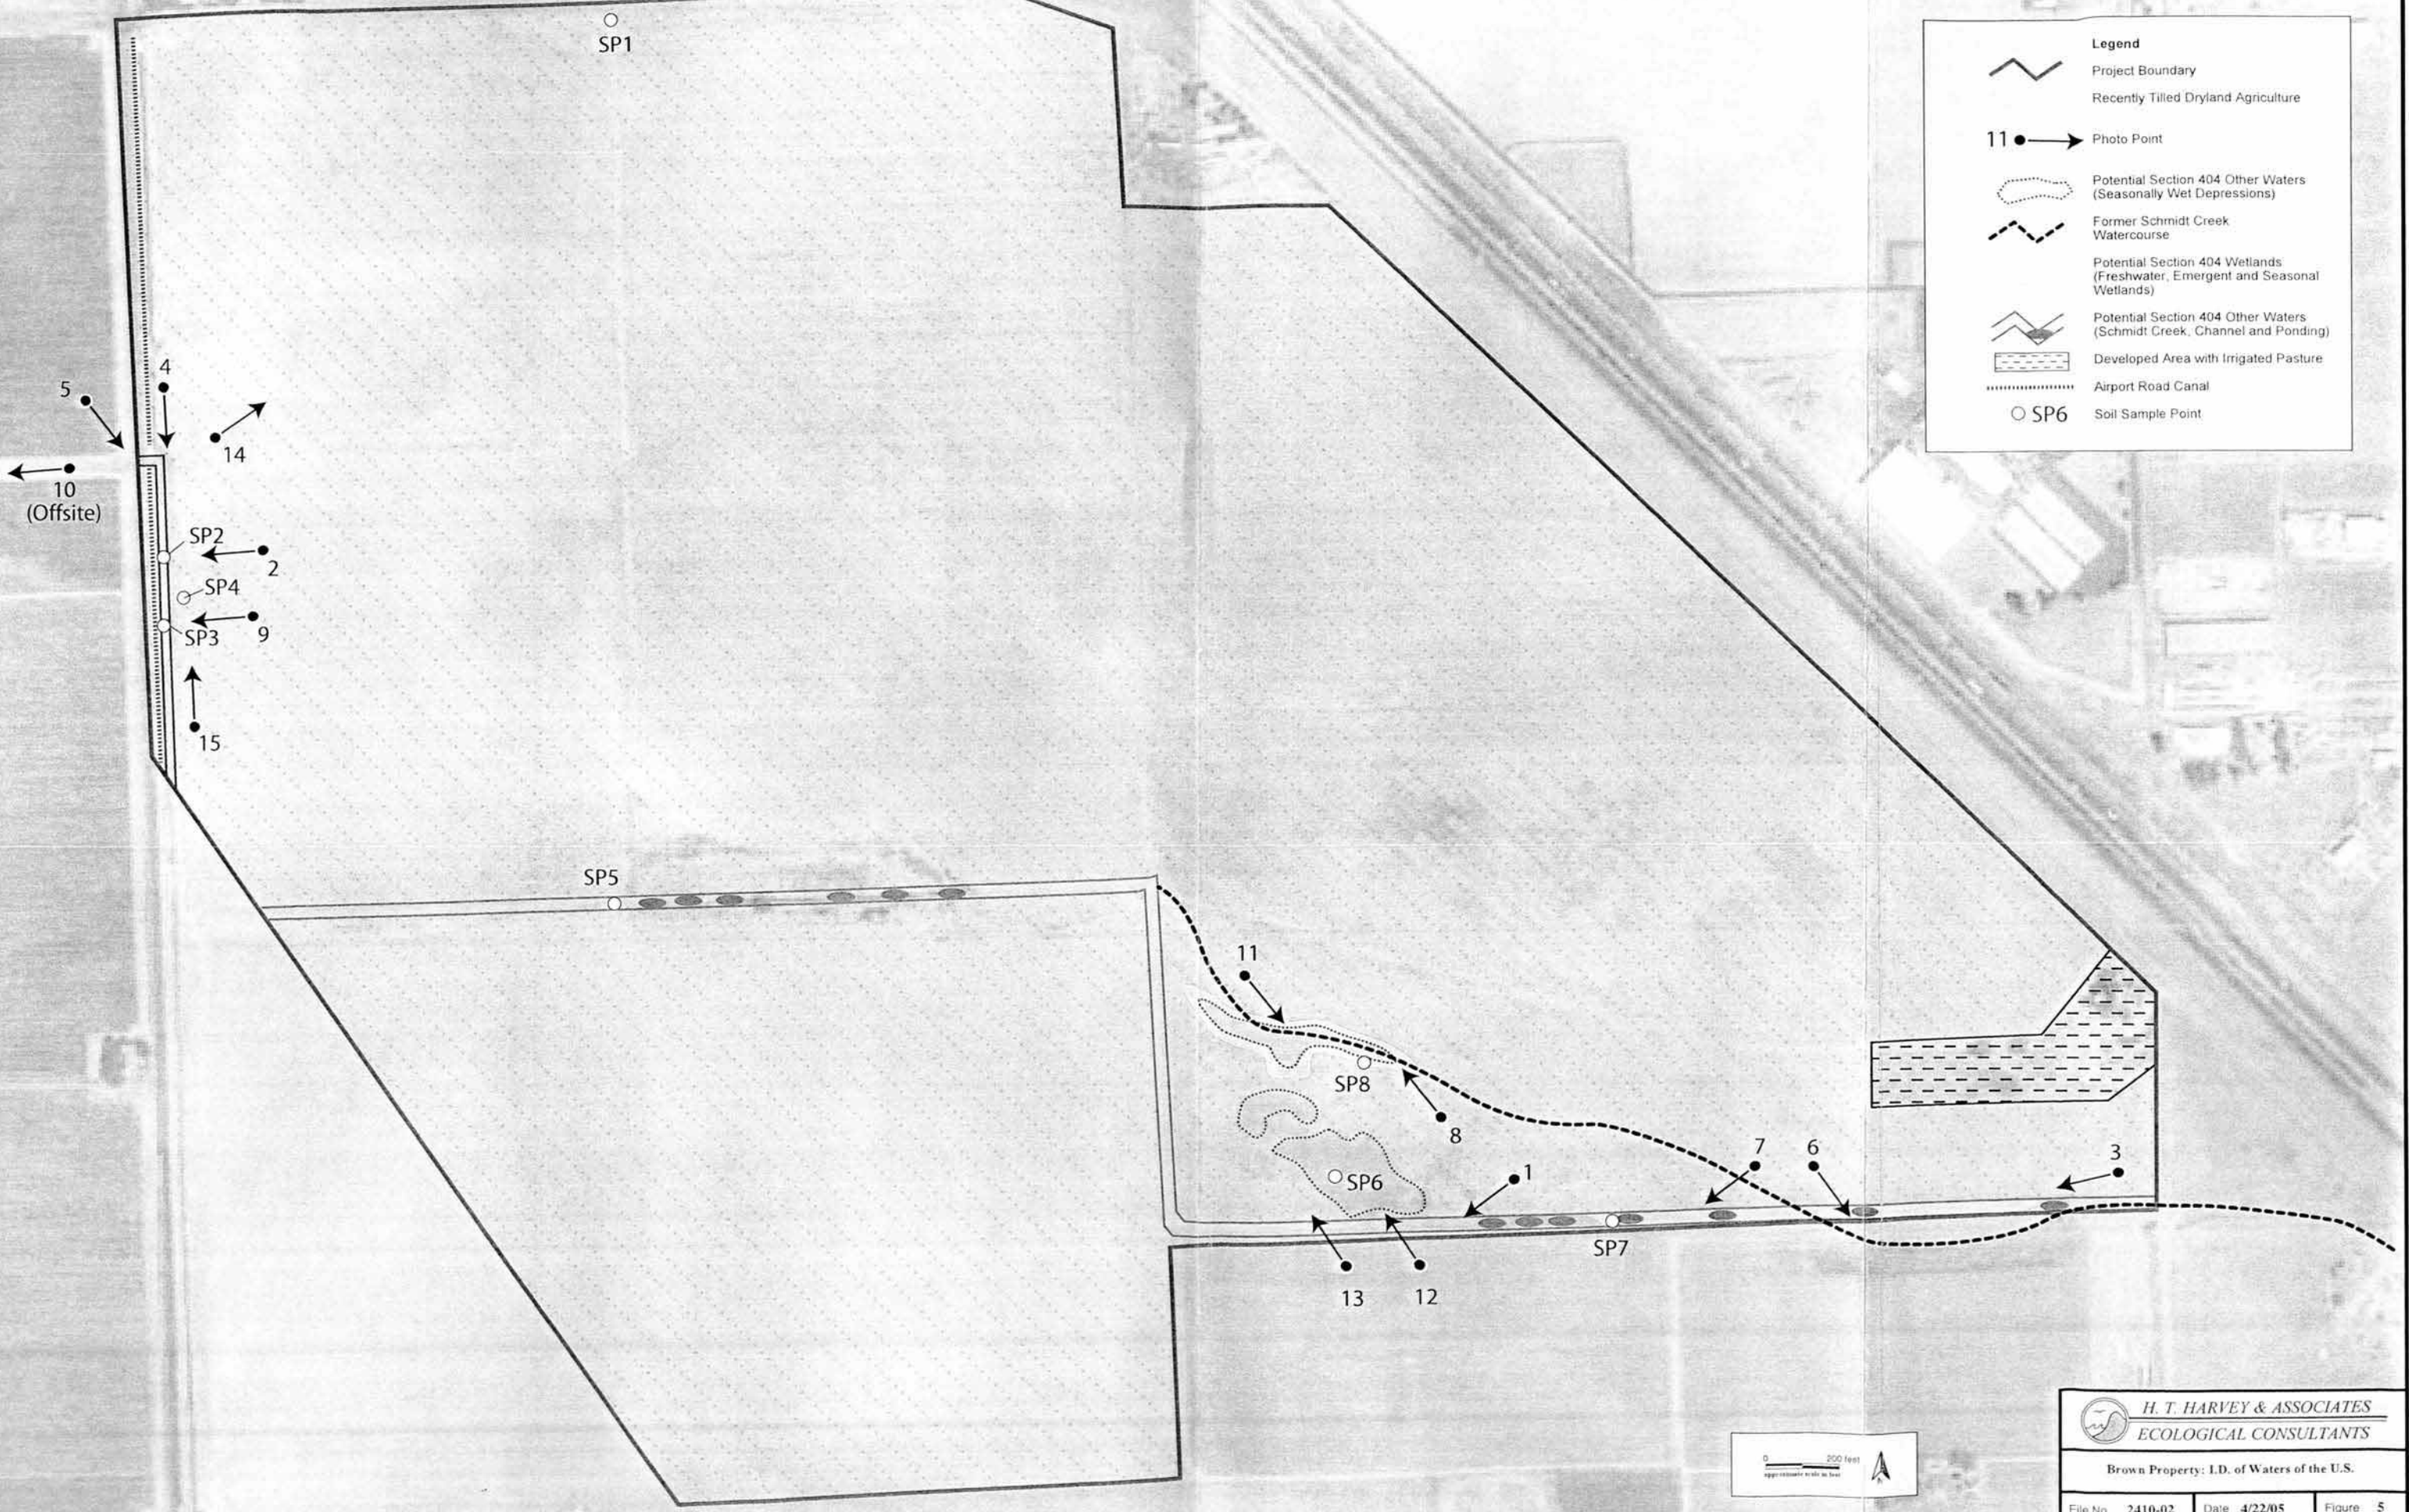
Currently, the 305-acre Brown property includes approximately 8.51 acres of jurisdictional waters. These jurisdictional waters include 0.95 acres of potentially jurisdictional wetlands located in various sections of Schmidt Creek, and 0.74 acres of seasonal wetland habitat in the former Schmidt Creek watercourse. In addition, potentially jurisdictional "other waters" occur as tributary water habitat throughout Schmidt Creek (4.55 acres). Ponding within the former Schmidt Creek watercourse and adjacent "wash" areas (2.27 acres) was observed in these areas. The hydrology supporting these areas is due to perching of incident rainfall, storm water runoff, and ordinary high water flows in various areas of the current and former Schmidt Creek watercourses. Specifically, the underlying hardpan forms the bed of the creek causing areas of deposited sands within the creek to remain saturated for extended periods during the winter, sustaining emergent species well into the growing season. The depth to the underlying hardpan has also remained shallow under the former watercourse since it was dewatered, resulting in extended saturation of these areas that support seasonal hydrophytes. The depth to the hardpan underlying the rest of the site is sufficiently deep enough to prevent perched hydrology from supporting wetland vegetation.

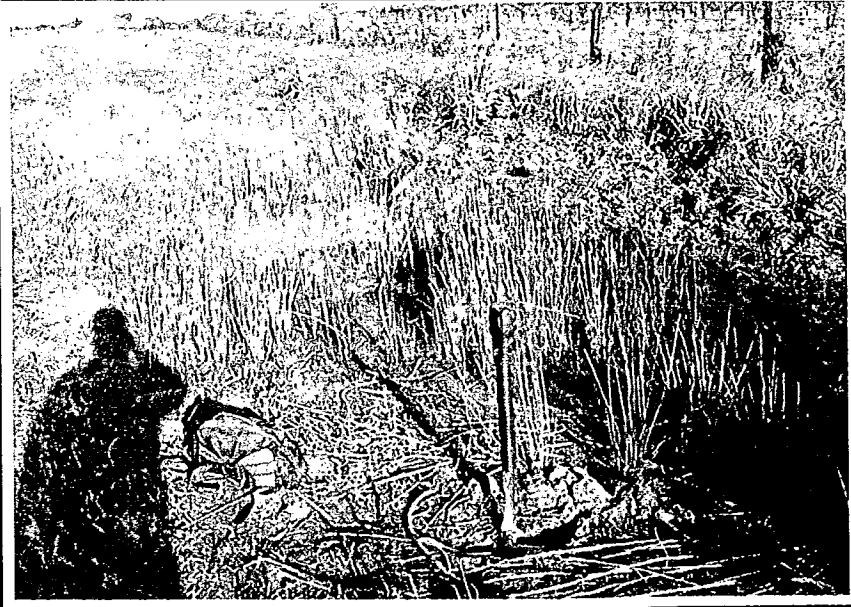
Remarks: • Sample point located just upstream of willow/cottonwood thicket, but is representative of most of the upstream east-west reach of the creek, which is variably dominated by fresh water emergent wetlands within the low-flow channel.

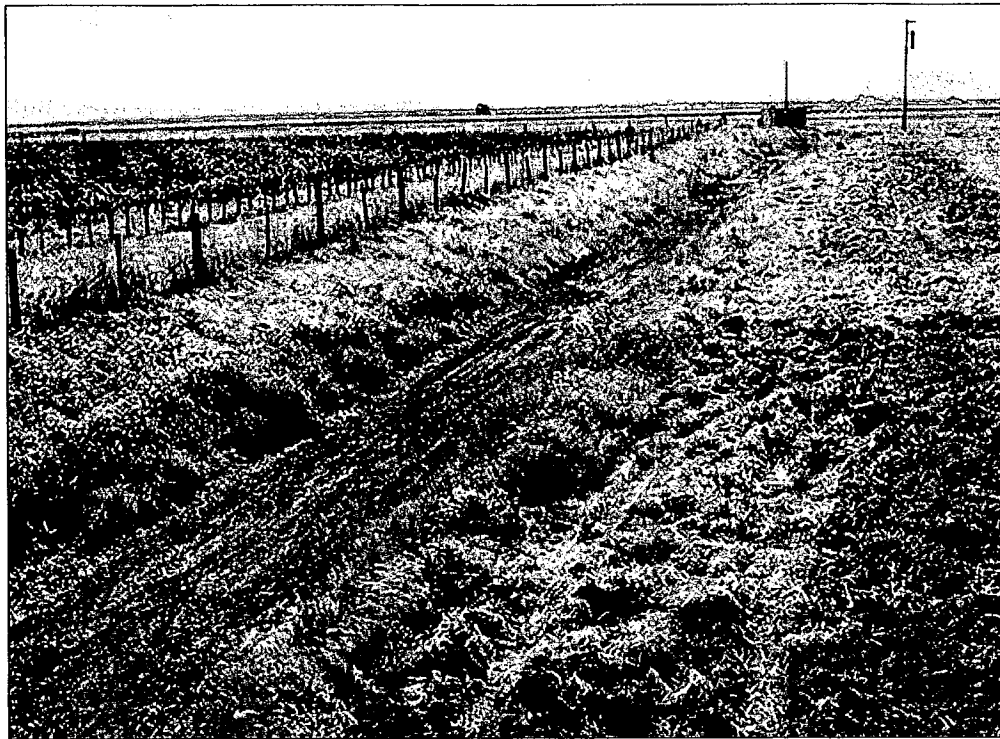
**Photo 1.** West view of Schmidt Creek channel, along the east-west southern property boundary. The creek bed in this reach of the channel consists of deep sand deposited over an underlying hardpan resulting in perched water with 1 foot of the creek bed.

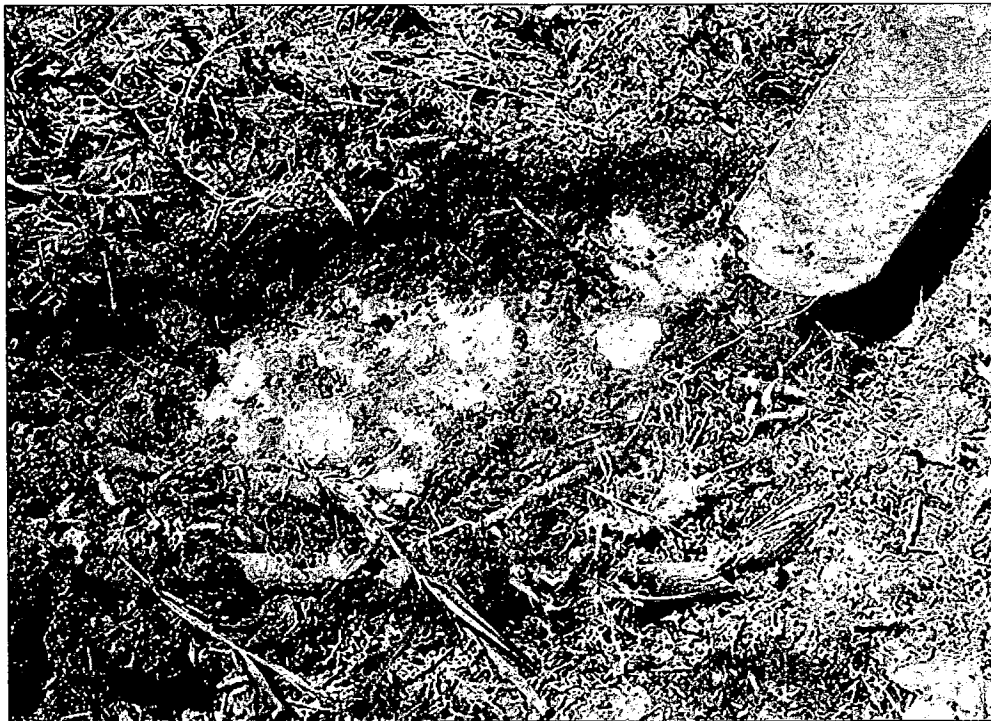
- An iron-silica hardpan underlies the entire site (Photo 2) and forms the ditch bottom which lies approximately three feet below the surrounding grade and is bordered by sandy spoils dredged from the creek course (Photo 3). The hardpan is partially obscured in reaches of the creek by sands deposited up to 18 inches deep. The hardpan slows or prevents downward percolation of incident rainfall, and storm water and irrigation runoff. This causes saturation and inundation to occur in areas of the site where the depth to the hardpan is relatively shallow.

**Soils.** The presence of the underlying dark brown (7.5YR 3/4) iron-silica hardpan (Photo 2) served as the primary hydric soil criteria, since the soils are subject to long duration flooding, particularly where the hardpan depth is shallower (NRCS 2004). While the sandy loams and loamy sands on site were predominantly light brownish gray to very dark grayish brown (10YR 6/2 to 10YR 3/2), many of the areas of potential wetlands have been saturated long enough during the growing season to develop sulfidic odor, also implying the presence of reducing conditions and aquic moisture regime (Photo 9). In addition, the wetlands in Schmidt Creek mostly correspond to the Atwater and San Joaquin soil phases on site, which are considered hydric, were found overlying unbroken hardpan (NRCS 2004). The seasonal wetlands along the former creek course are primarily underlain by the Tujunga soil series that is also considered hydric when overlying hardpan. The soils survey does not identify the Tujunga soil phase occurring on site as having an underlying hardpan, but the presence of one was confirmed in the field, which meets the hydric soil criteria for wetlands occurring along the former creek course.

**Photo 2.** Close up view of the rusty brown iron-silica hardpan underlying most of the project site. The photo was taken within the Schmidt Creek channel, where the depth to this hardpan varies with the sand deposition.

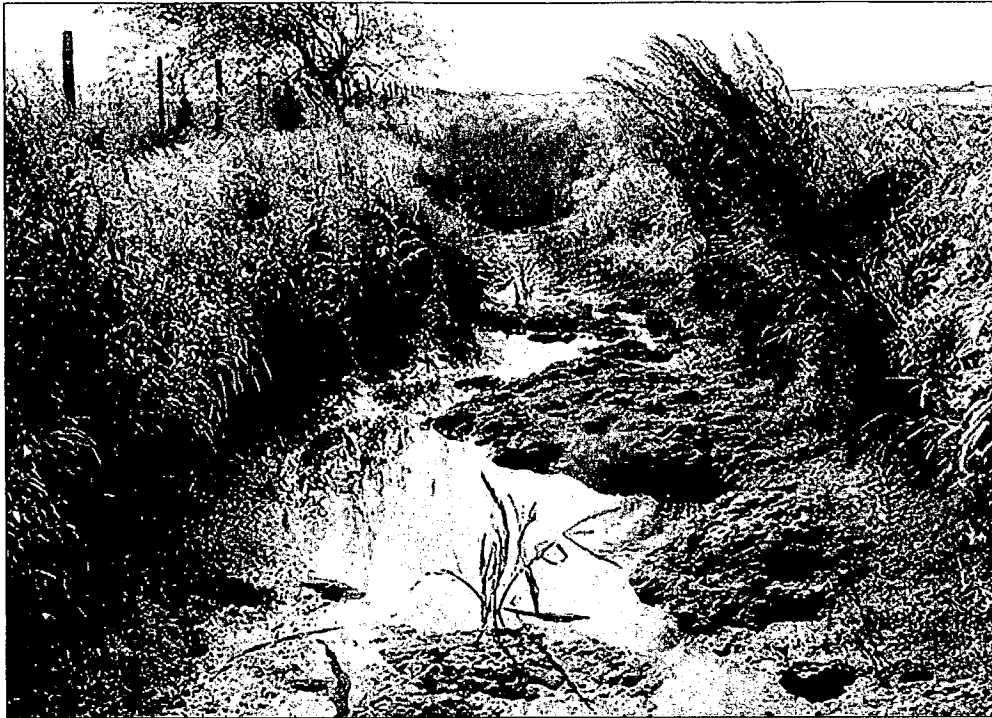
**Hydrology.** Standing water was observed as isolated ponds in the creek bed and was up to 24 inches deep (Photo 3). The water is perched by the underlying hardpan, and causes adjacent areas of deposited sands to remain saturated for extended periods during the winter, allowing hydrophytes to become established (Photo 9). Drift lines and water marks also exist within the creek bed, but water is only expected to flow in the creek temporarily following storm events. Scouring and shifting of deposited sands in the creek bed during flash flows may cause the distribution of wetlands within the creek to change from year to year. Elsewhere, areas of the former creek course supporting seasonal wetland habitat were found to be highly saturated, and have standing water in the soil sample pits. These areas were somewhat lower in elevation compared to the rest of the project site, and only lie approximately 1-foot above the elevation of the creek bed. As such, the depth to the hardpan is relatively shallow, and the saturation of these areas is attributable to the perching of incident rainfall by the underlying hardpan.

**Photo 3.** West view of the Schmidt Creek channel, from its upstream end. The hardpan underlying the property is exposed at this location, causing isolated ponding within the channel. Note the freshwater emergent vegetation growing in an area of sand deposition just downstream.

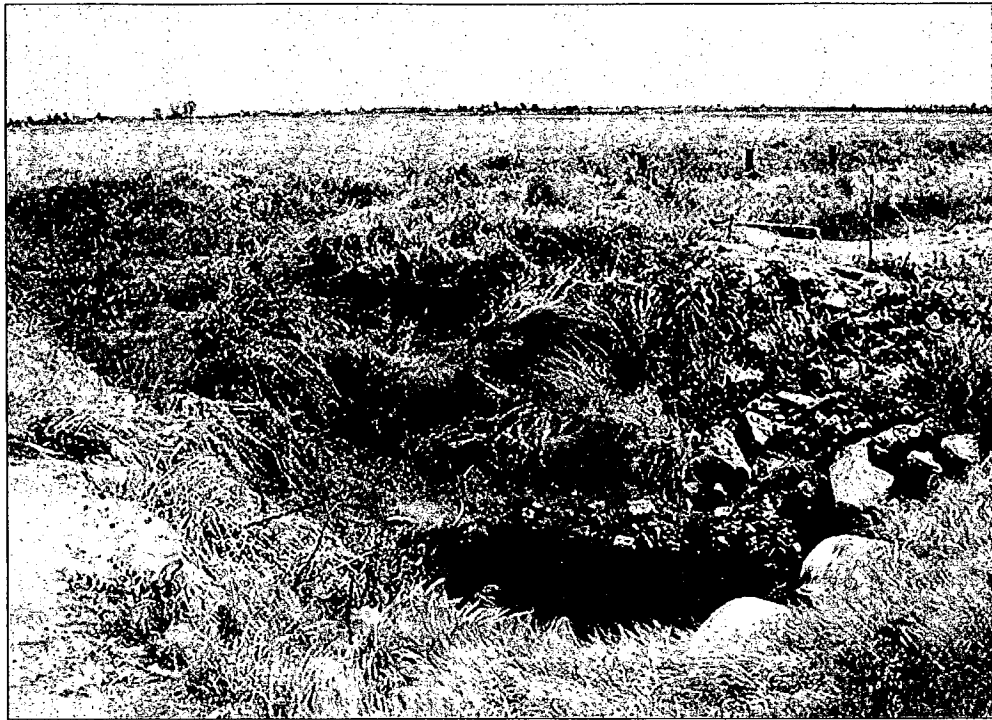
**Photo 5.** Southeast view of the Schmidt Creek channel as it enters the culverts under Road 23. The headwall of the concrete vault siphon of the Airport Ditch is located in the upper-middle right hand corner of the photo.

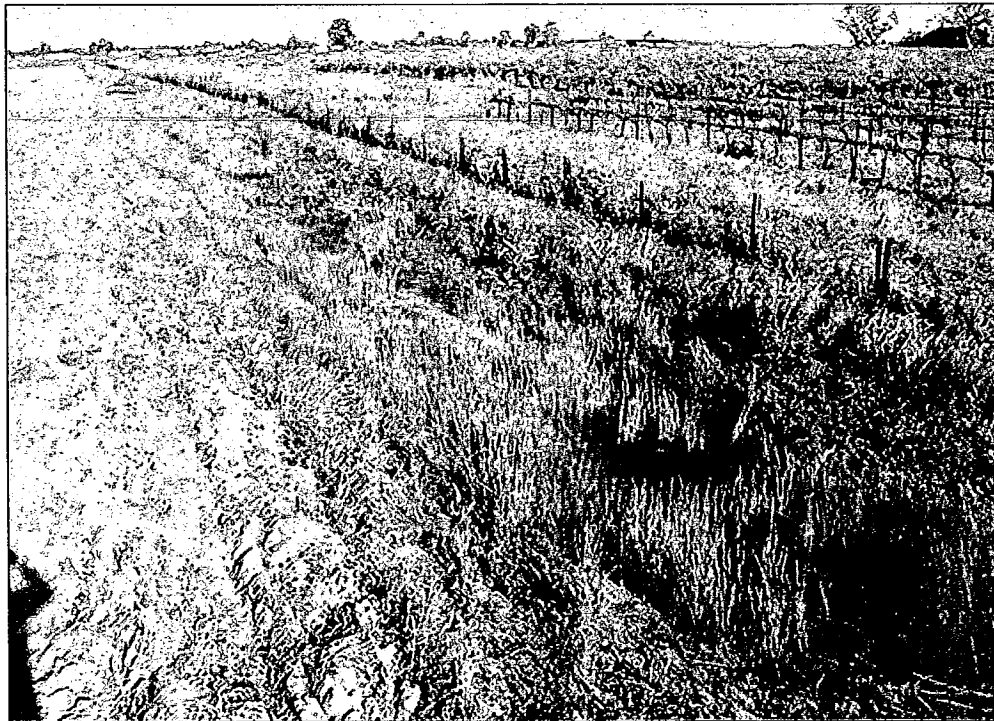
**Vegetation.** Approximately 0.95 acres of freshwater emergent marsh wetland habitat is present in two reaches of Schmidt Creek. These include the north-south reach parallel to Road 23, and in the eastern-third of the creek alignment (Photo 6). These reaches are dominated by creeping spikerush (*Eleocharis macrostachya*; OBL), Baltic rush (*Juncus balticus*; OBL), and watercress (*Rorippa nasturtium-aquaticum*; OBL). Less dominant hydrophytic species occurring within the creek bed include common monkeyflower (*Mimulus guttatus*; OBL), coast popcorn-flower (*Plagiobothrys undulatus*; FACW+), and Himalayan knotweed (*Polygonum polystachyum*; FAC). Sandbar willows (*Salix exigua*; OBL) and Fremont cottonwoods (*Populus fremontii*; FACW) are also growing in a few areas of the creek bottom but do not form contiguous riparian habitat (Photo 7). Approximately 0.74 acres of seasonal wetland occurs within a low area of the historical creek course, and is dominated by Mediterranean barley (*Hordeum marinum* ssp.

**Photo 6.** Southeast view of the Schmidt Creek channel, along the east-west southern property boundary. Note the freshwater emergent vegetation and isolated ponding growing in an area of sand deposition throughout this upstream reach of the creek.

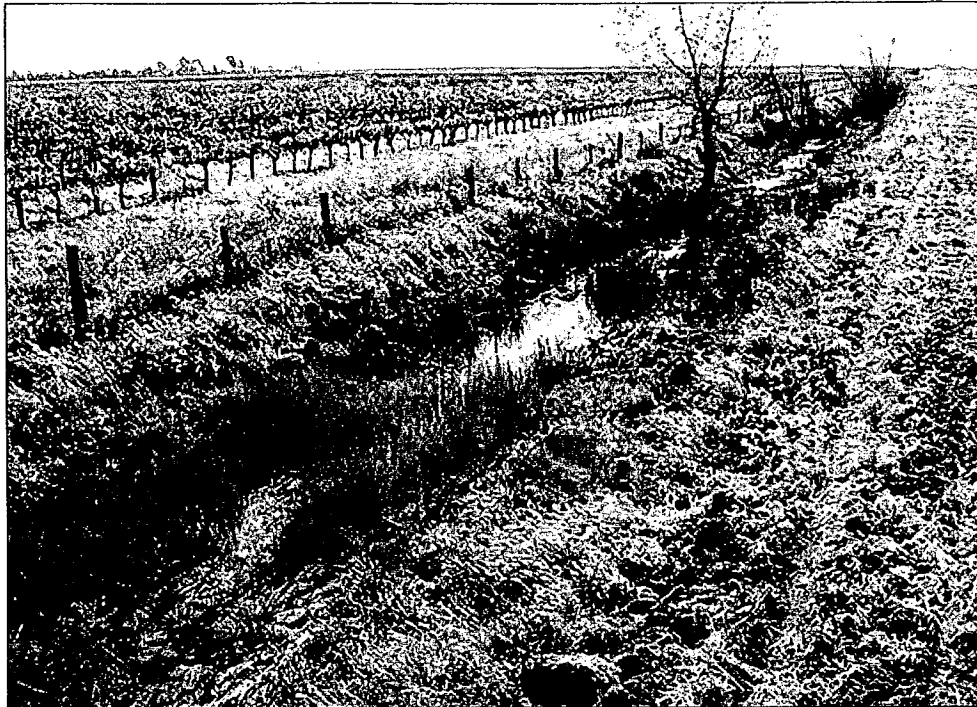
**Photo 7.** Southwest view of the Southeast view of the Schmidt Creek channel, along the east-west southern property boundary. The freshwater emergent vegetation in the channel is a continuation of the wetlands pictures in Photo 6. Note the isolated cottonwood and willow trees in the background. These trees do not form distinct riparian habitat.

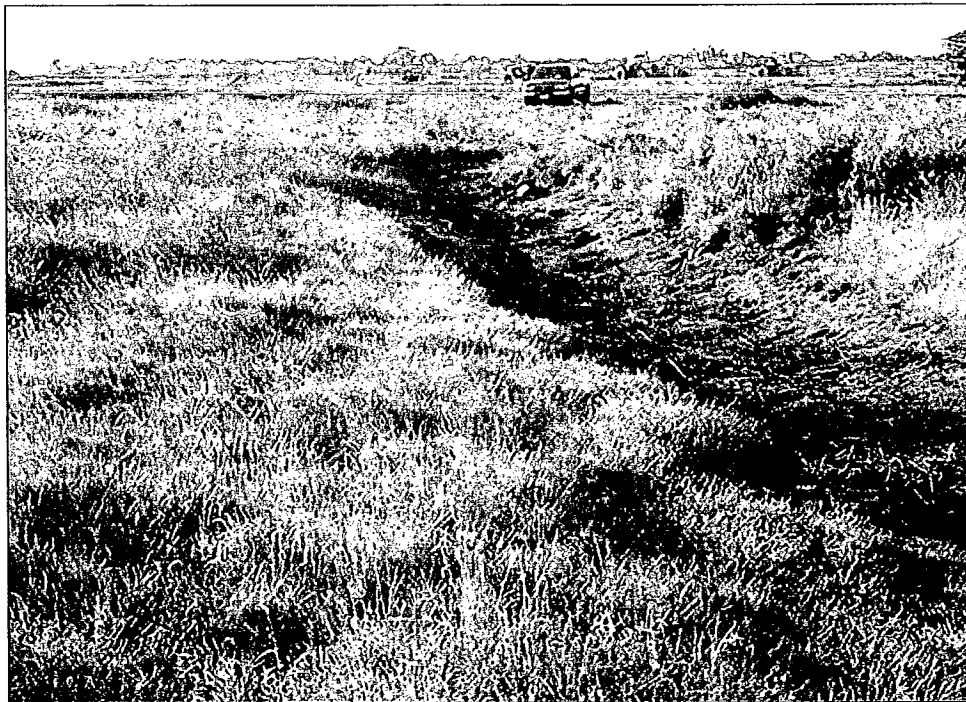
**Photo 8.** Northwest view of the former watercourse of Schmidt Creek. The edges of the lo-flow channel are dominated by seasonal wetland habitat. The depth to the underlying hardpan has remained shallow in this area, providing adequate hydrology for wetland establishment due to perching of incident rainfall.

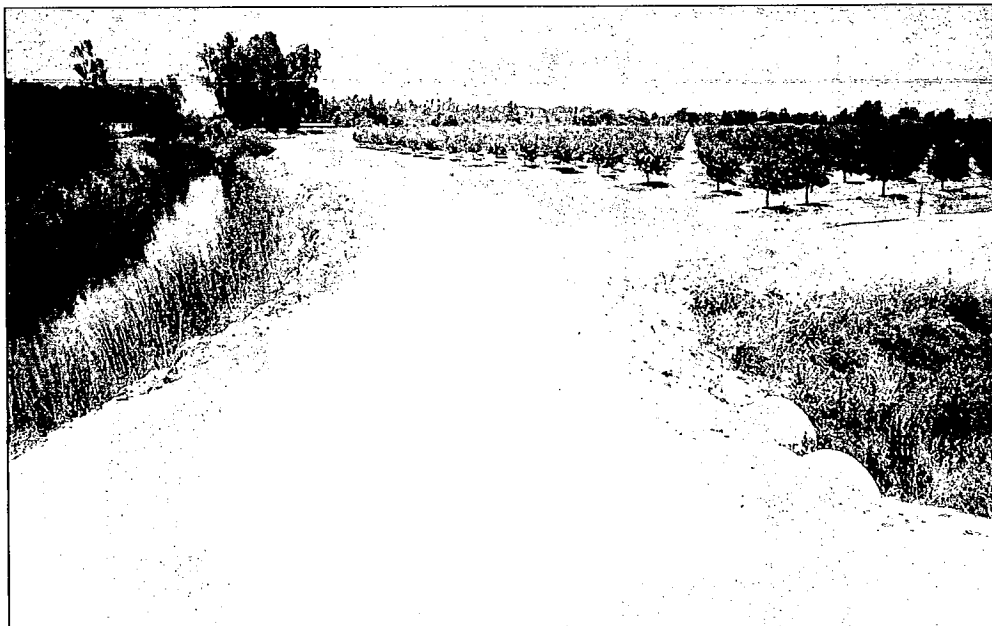
**Photo 10.** North view of the off-site confluence of the Schmidt Creek channel (right) and Dry Creek (left). Dry Creek is a perennial stream that ultimately flows into the Fresno River.

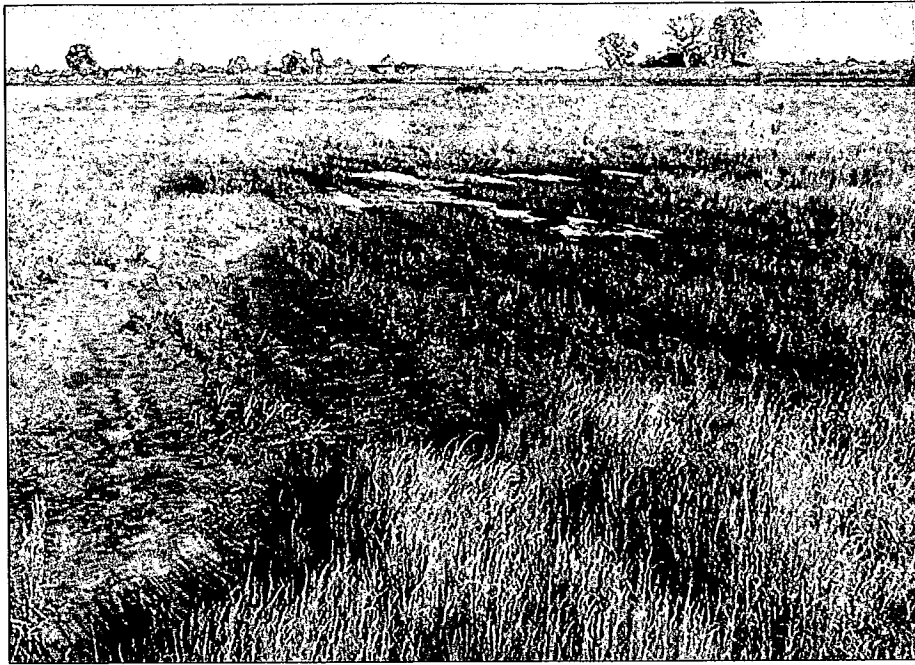
**Photo 11.** Southeast view of the former Schmidt Creek watercourse. The low-flow channel is no longer discernable, but the depth to the underlying hardpan remains shallow in this area and the perching of incident rainfall results in extended ponding, inhibiting vegetative growth until much later in the season. Such areas were considered areas of potential 'other water' jurisdiction.

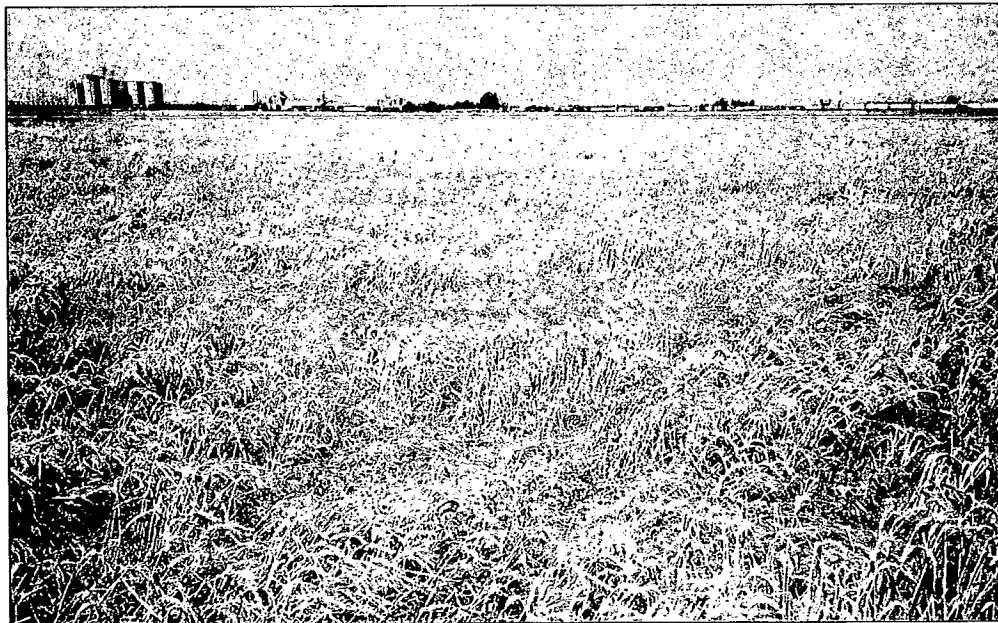
**Photo 14.** Northeast view of the dryland wheat crop, which is planted to the site later in the spring. This photo was taken in June 2004.

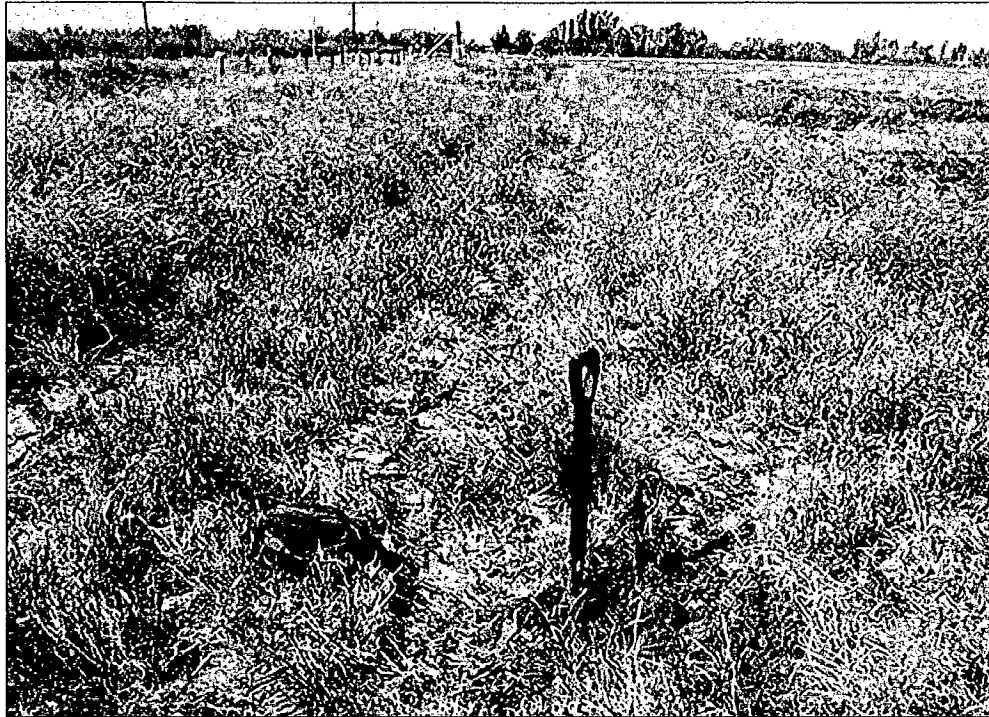
Remarks: • Sample point located at edge of unplowed field dominated by rye and barley not reminiscent of any wetland habitat.  
• Underlying hardpan is sufficiently deep that extended ponding is highly limited.

**Photo 15.** North view of sample point 4. Temporary ponding capable of supporting seasonal wetland vegetation or algal matting may occur in isolated upland areas such as this one where the depth to the hardpan is slightly reduced due to uneven tillage from year to year. These areas are not expected to persist and were not considered potential wetland.
